Re: February 2015 Monthly Progress Report

Gasco Sediments Site within the Portland Harbor Superfund Site

Visual Observations Log Form

Monitoring Period: Monthly (Year 9)— February 2015

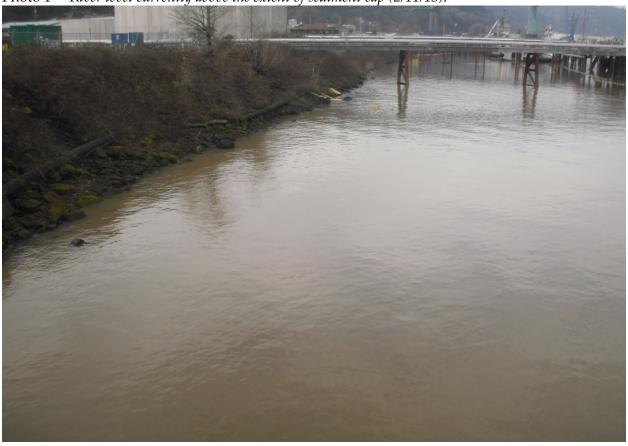
No erosion/deposition is evident along the shoreline. The shoreward extent of the cap was not visible due to high river water elevation and the extents of the organoclay mat material were also submerged. (Photo 1).

Photo 1 - River level currently above the extent of sediment cap (2/11/15):

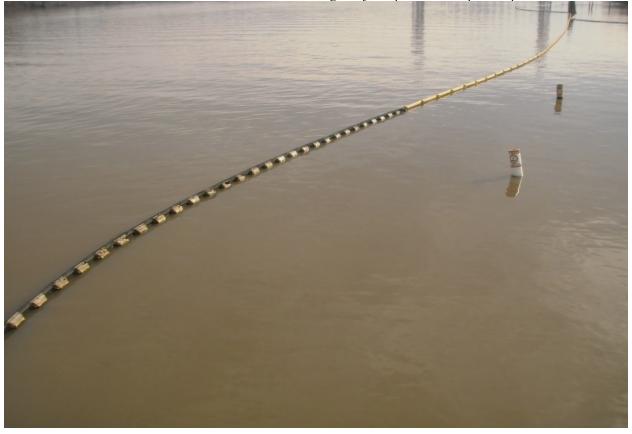
Observations of Long-term Controls (i.e., oil booms, organo-clay mat, etc.) During the observation, the Fuel and Marine Marketing (FAMM) containment boom was placed across the cap area, between the upriver corner of the ship dock and the wooden dolphin (near the upriver extent of the site and near the Siltronic Corporation outfall). Buoys that identify the cap area to mariners are in place as installed. The position of the FAMM oil boom, warning buoys, and a general overview of the site shoreline is shown in Photo 2.

Photo 2 - FAMM oil boom shown and mariner warning buoys in place across pilot cap area. (2/11/15):

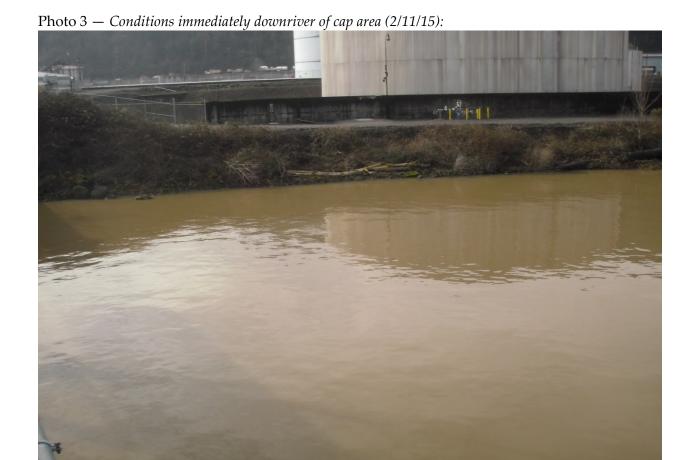
No sheen is evident in or around the cap area. Photo 3 shows the water surface and shoreline immediately downriver of the sediment cap.
